SHWE TAUNG CEMENT COMPANY LIMITED
BIANNUAL ENVIRONMENTAL MONITORING REPORT
(January 2023 to June 2023)

0	February 2024	Bi-annual reporting to ECD

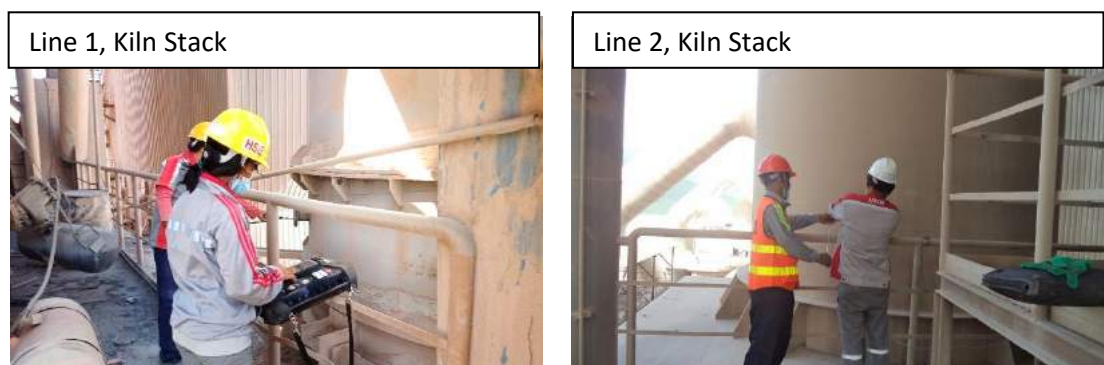
Figure 3. Location of Kiln Stack Emission Monitoring

Figure 3 and 4 show the location of Kiln Stack Emission Monitoring and Ambient Air Monitoring monthly by Myanmar National Environmental Quality (Emission) Guidelines (2015) for cement and lime manufacturing (for NOx, SO2, PM2.5, PM10 etc.) are the parameters measured.

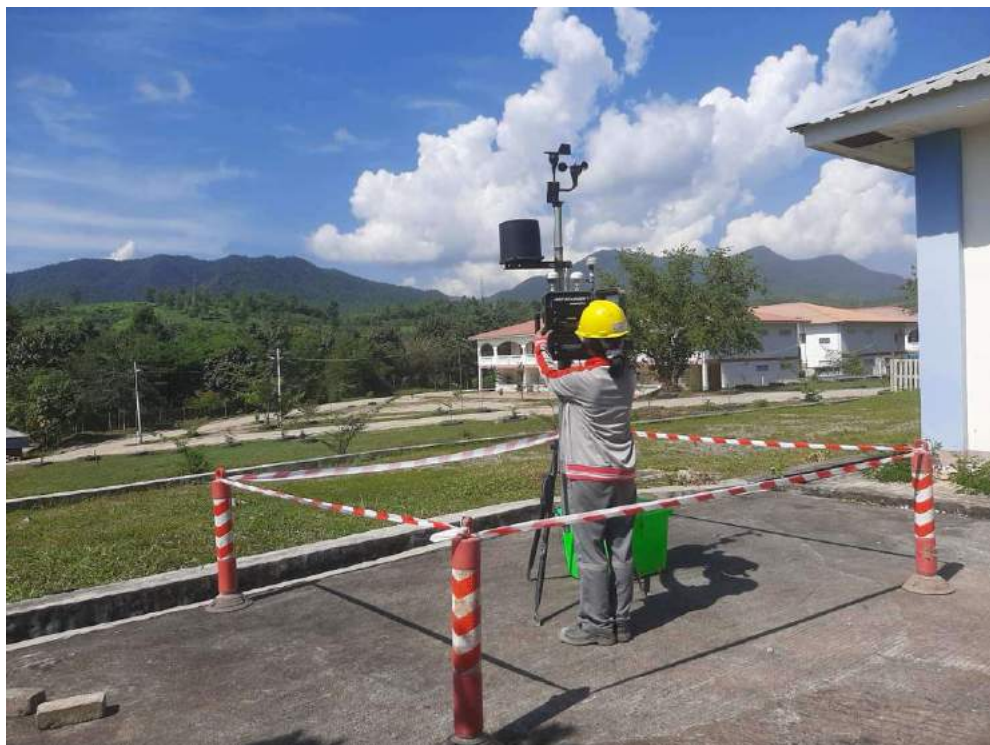
Figure 4. Ambient Air Quality Monitoring

Ambient air quality monitoring location had been selected by identifying potentially affected with consideration given to the prevailing wind conditions through Operation and Construction activities.

No	Monitoring Location	Latitude	Longitude
1	AQ1_Worker Accommodation	20°50'56.15"N	96°23'35.97"E
2	AQ2_Ku Pyin Village	20°53'20.47"N	96°23'27.58"E
3	AQ3_Pyi Nyaung Village	20°49'4.58"N	96°23'40.42"E

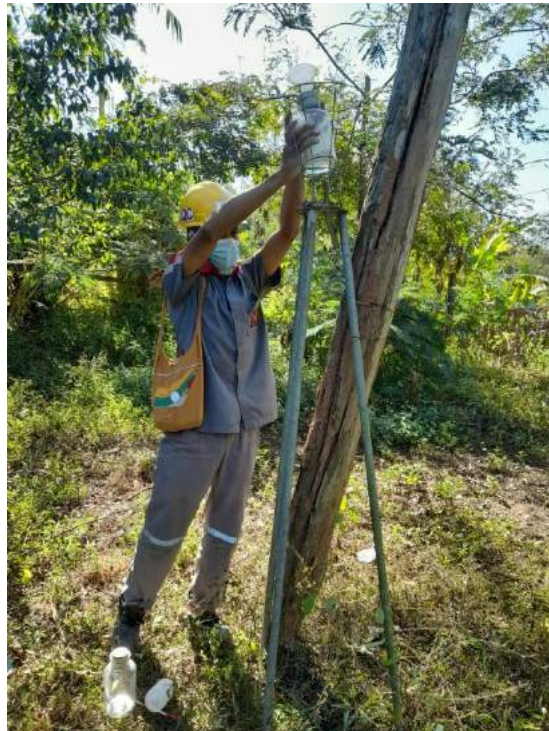
Figure 8 – Dust Deposition Monitoring

STC monitored dust deposition with 6 points at cement plant, housing/ accommodation area, Ku Pyin and Pyi Nyaung village. The use of fabric/bag filter system and electrostatic precipitator to collect and control fine suspended particulate emissions are implemented in both lines of cement plant. Water suppression was also undertaken on the roads by using the water from sedimentation ponds to mitigate dust emission on surrounding area in plant site, quarries and plant accommodation area.

No	Monitoring Location	Latitude	Longitude
1	STC Accommodation (Ingyin Hostel)	20°51'23.1"N	96°23'34.7"E
2	STC Accommodation (55acres)	20°50'54.5"N	96°23'34.8"E
3	Ku Pyin (Behind Library)	20°53'26.9"N	96°23'24.8"E
4	Ku Pyin (Primary School)	20°53'25.7"N	96°23'33.6"E
5	Pyi Nyaung (Near Main Road)	20°49'09.5"N	96°23'50.9"E
6	Pyi Nyaung (Information Center)	20°49'03.9"N	96°23'40.6"E

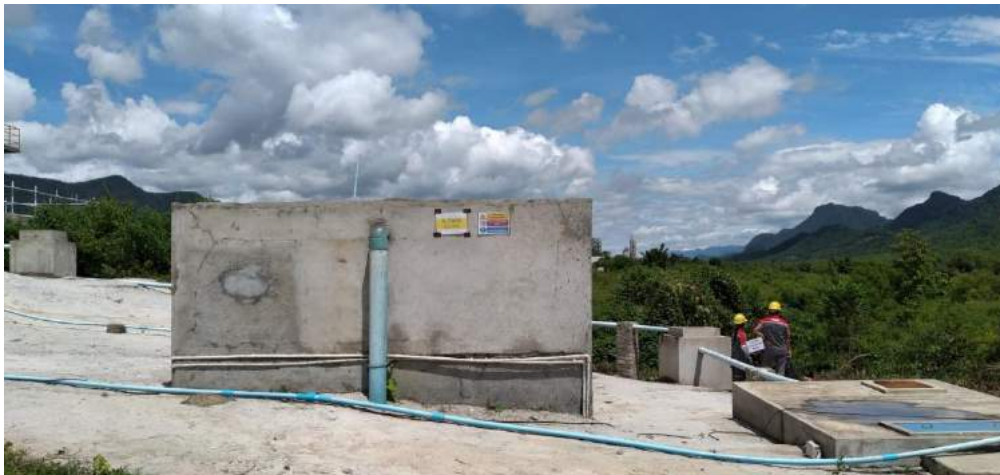
Figure 9 - Bio Tank

No.	Sampling Location	Latitude	Longitude
1	Bio Tank Effluent Discharge to Sedimentation # 9	20°50'51.2"N	96°23'45.4"E
2	Supply Water	20°51'35.3"N	96°23'37.7"E
3	Sedimentation Pond Effluent	20°52'14.0"N	96°23'23.6"E

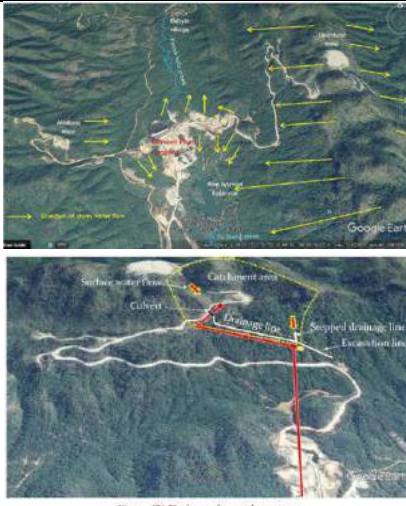
<p style="text-align: center; font-size: small;">Figure (2) Drainage for catchment area</p>
	<ul style="list-style-type: none"> Divert runoff from the mudstone quarry to an appropriately sized and maintained sedimentation pond to allow adequate retention time for suspended solids to settle; 	Constructed sedimentation pond dual stage.	<p style="font-size: x-small;">Sedimentation pond from storm water runoff to allow adequate retention time for suspended solids to settle before entering wetlands area.</p> <p style="text-align: center; font-size: x-small;">Location Map of Sedimentation Pond at STC Site</p>

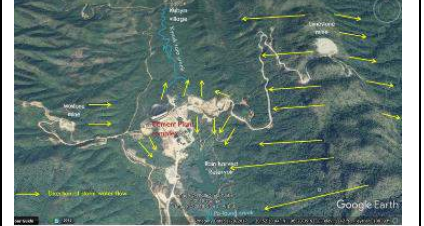
<ul style="list-style-type: none"> STC will prepare and implement a Storm water Management Plan taking into account the mitigation committed above. 	<p>Plan have been developed and construction on progress for Line 2 area. Line 1 area was constructed since 2014.</p>

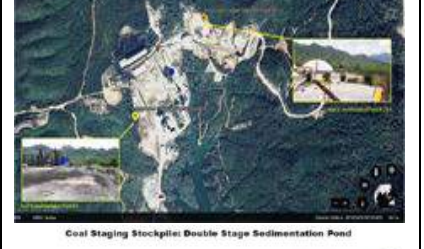
<p style="text-align: center; font-size: x-small;">Coal Staging Stockpile: Double Stage Sedimentation Pond</p>

<ul style="list-style-type: none"> Runoff from the laterite and limestone staging areas shall be diverted to retention ponds and may be used for greening, dust suppression or discharged to the onsite reservoir. 	<p>Constructed sedimentation pond dual stage and reuse for gardening and dust control.</p>

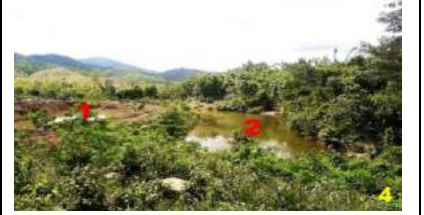
<ul style="list-style-type: none"> For the coal storage area, STC has agreed to cover this area. Water from the roof will be diverted via storm water drains to retention ponds and may be used for greening, dust suppression or discharged to the onsite reservoir. Runoff collected by the interceptor drains (small volume) within the covered coal storage area will be diverted for treatment at the wastewater treatment plant. 	<p>Constructed sedimentation pond triple stage.</p>

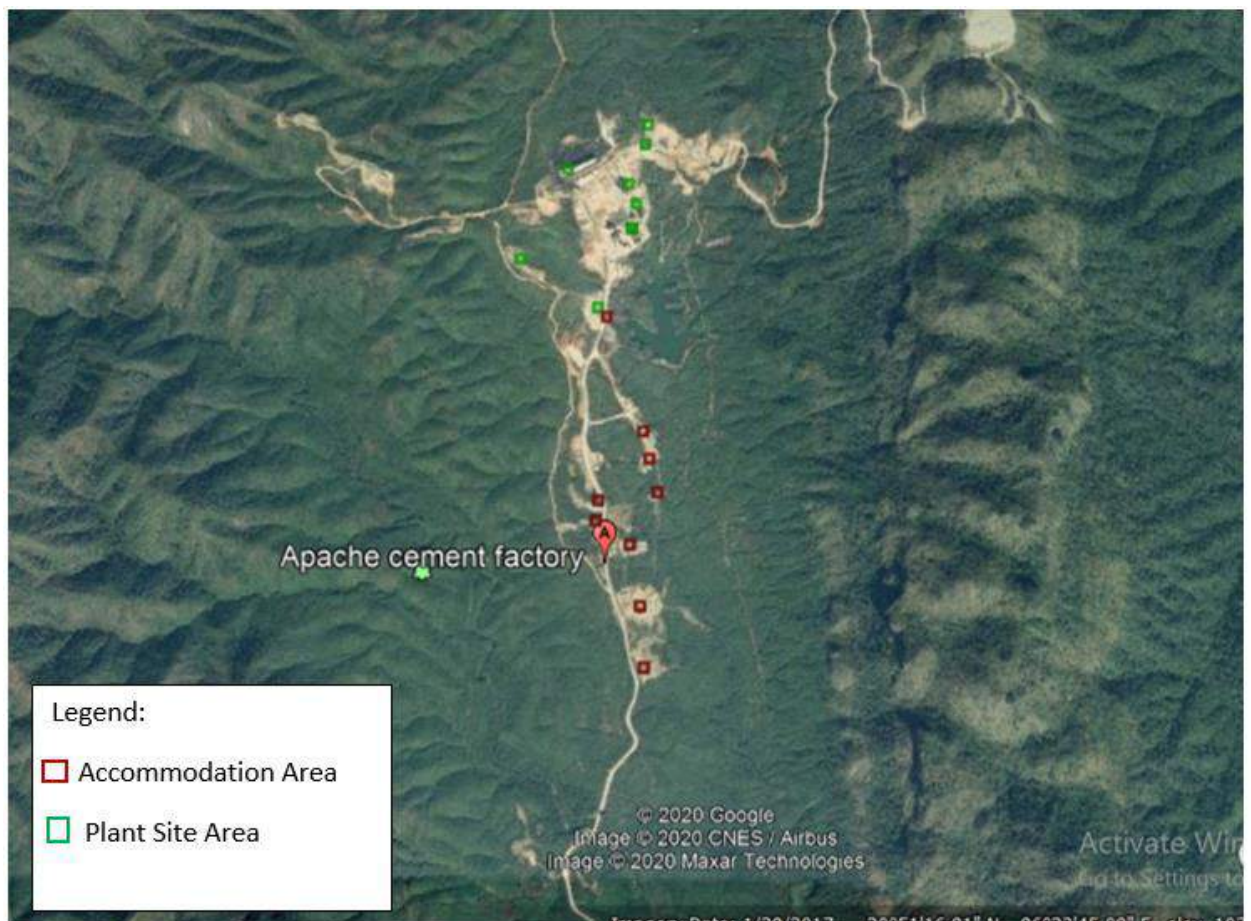
Figure14 - Location Map of Collection Points of All Generated Wastes from Plant Site and Accommodation Area

In Shwe Taung Cement Factory, collect non-hazardous waste generated from plant site and accommodation area every day and dispose them to Temporary Non-hazardous Storage Area. For kitchen wastes, compost or use as animal feed in nearby villages. On the other hand, dispose laboratory and clinical wastes to Meikhtila Incinerator, Meikhtila District, Mandalay Region, approved by Meikhtila City Development Committee and have plan to dispose hazardous wastes to Golden Dowa Eco-system Myanmar Co., Ltd., Accredited Waste Management Company. Figure 15 and 16 shows location map of waste disposal area and waste collection points.

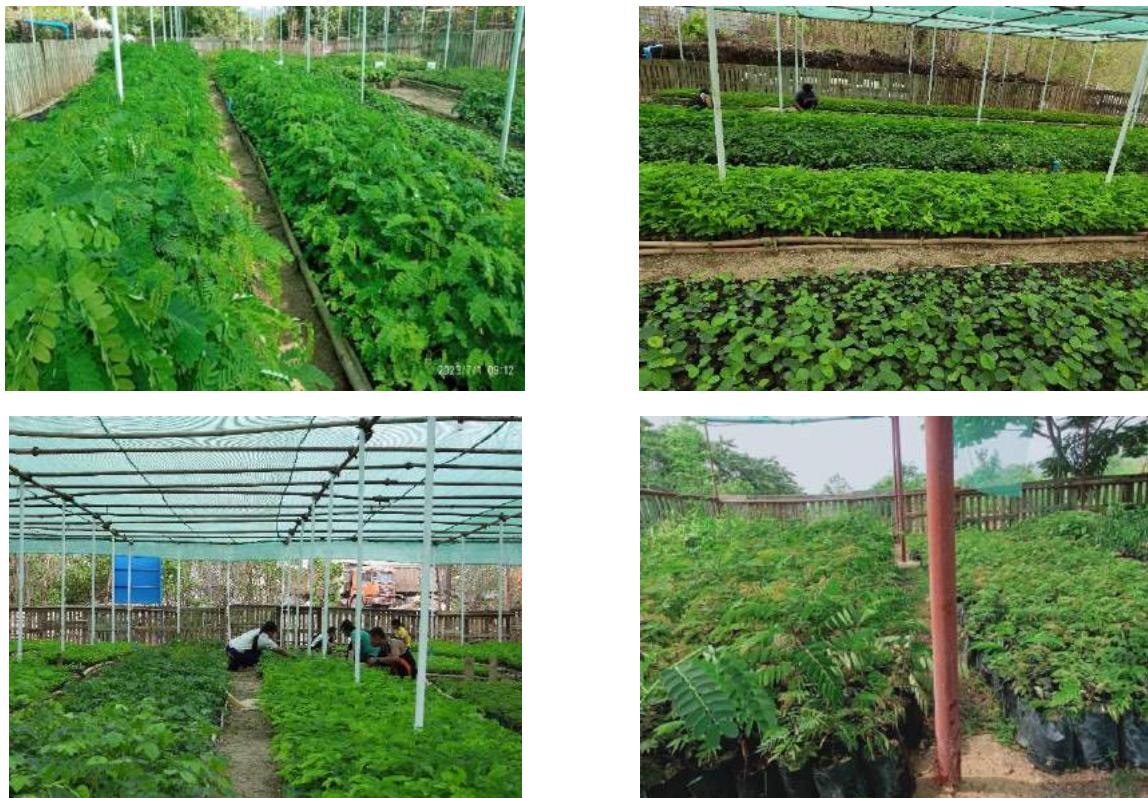
Figure 19 – Patching Process at Ecosystem Restoration Plantation

Name of Production	Plantation Acre	Established Year	Location	Number of Patching in 2023	Name of Patched Species
Mudstone	33	2017	Ku Pyin Reserved Forest	3,564	Mazali, Kokko, Thit Padauk
Limestone	15	2017	Ku Pyin Reserved Forest	1,192	Mazali, Kokko, Thit Padauk
Limestone	50	2018	Ku Pyin Reserved Forest	15,000	Mazali, Kokko, Thit Padauk
Limestone & Red clay and others	100	2019	Pyi Nyaung Reserved Forest	8,400	Mazali, Kokko, Thit Padauk, Teak, Sein Pan
Total	198	198		28,156

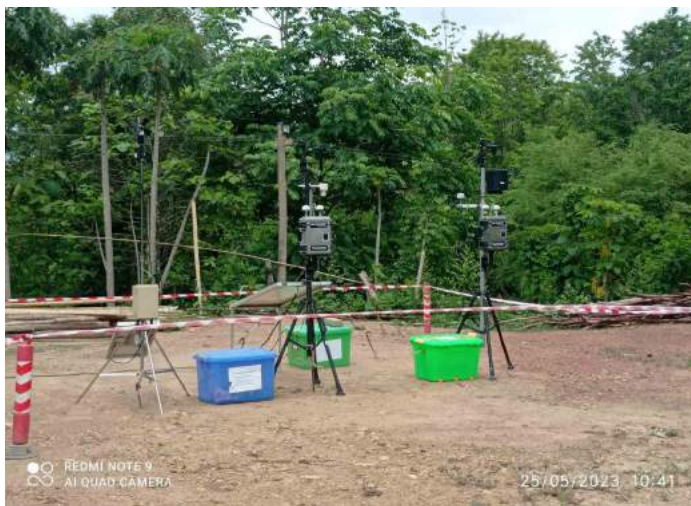
- ရွှေတောင်ဘီလပ်မြေကုမ္ပဏီလီမိတက်၏ ဓာတ်ခွဲခန်းနှင့်အရည်အ သွေးထိန်းချုပ်ရေးဌာနမှ ၂၀၂၃ခုနှစ်၊ ဧပြီလ မှ ဇွန်လအတွင်း ပြည်ညောင်ကျေးရွာနှင့် ကူပြင်ကျေးရွာများတွင် သောက်ရေသုံးရေ နှင့်အမှုန်များ တိုင်းတာစစ်ဆေးခဲ့ပြီး ၎င်းစစ်ဆေးမှုရလဒ်များအား ကမ္ဘာ့ကျန်းမာရေးအဖွဲ့နှင့် အမျိုးသားပတ်ဝန်းကျင်ဆိုင်ရာ အရည်အ သွေးထုတ်လွှတ်မှုလမ်းညွှန်ချက်များနှင့် ကိုက်ညီမှုကြောင်းကို ကျေး ရွာအုပ်ချုပ်ရေးမှူးရုံးအနီးရှိ ရေသန့်စက်တွင်လည်းကောင်း၊ ကူပြင် ကျေးရွာရှိ ထာဝရအလင်းတန်း စာကြည့်တိုက်တွင် လည်းကောင်း၊ ပြည်ညောင်ကျေးရွာရှိသတင်းအချက်အလက်ဆိုင်ရာဗဟိုဌာနနှင့်စာ ကြည့်တိုက်တွင်လည်းကောင်းသတင်းထုတ်ပြန်ကြေငြာခဲ့ပါသည်။
- ရွှေတောင်ဘီလပ်မြေကုမ္ပဏီလီမိတက်မှ ၂၀၂၃-ခုနှစ်၊ ဇွန်လမှစ၍ ပြည်ညောင်နှင့်ကူပြင်ကျေးရွာများတွင် လေထုတိုင်းတာခြင်း၊ အပူ ချိန်တိုင်းတာခြင်းနှင့် မိုးရေချိန်တိုင်းတာခြင်း၊လုပ် ငန်းစဉ်များအား ပြန်လည်ဆောင်ရွက်လုပ်ကိုင်လျက်ရှိပါသည်။

ပုံ - ကူပြင်ကျေးရွာတွင် လေထုတိုင်းတာစစ်ဆေးနေစဉ်။

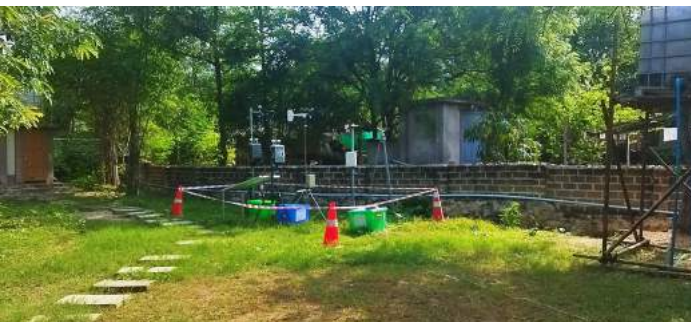
ပုံ - ပြည်ညောင်ကျေးရွာတွင် လေထုတိုင်းတာစစ်ဆေးနေစဉ်။
