SHWE TAUNG CEMENT COMPANY LIMITED
BIANNUAL ENVIRONMENTAL MONITORING REPORT
(July 2022 to December 2022)

0	February 2024	Bi-annual reporting to ECD

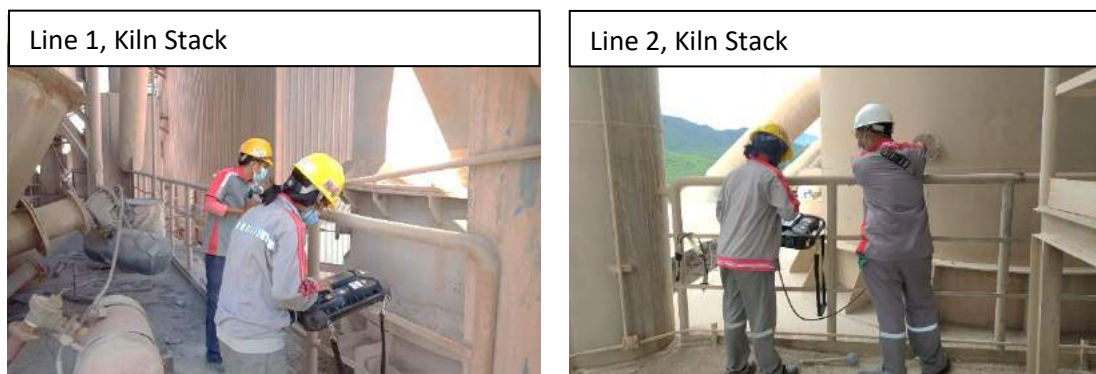
Figure 3. Location of Kiln Stack Emission Monitoring

Figure 3 and 4 show the location of Kiln Stack Emission Monitoring and Ambient Air Monitoring monthly by Myanmar National Environmental Quality (Emission) Guidelines (2015) for cement and lime manufacturing (for NOx, SO2, PM2.5, PM10 etc.) are the parameters measured.

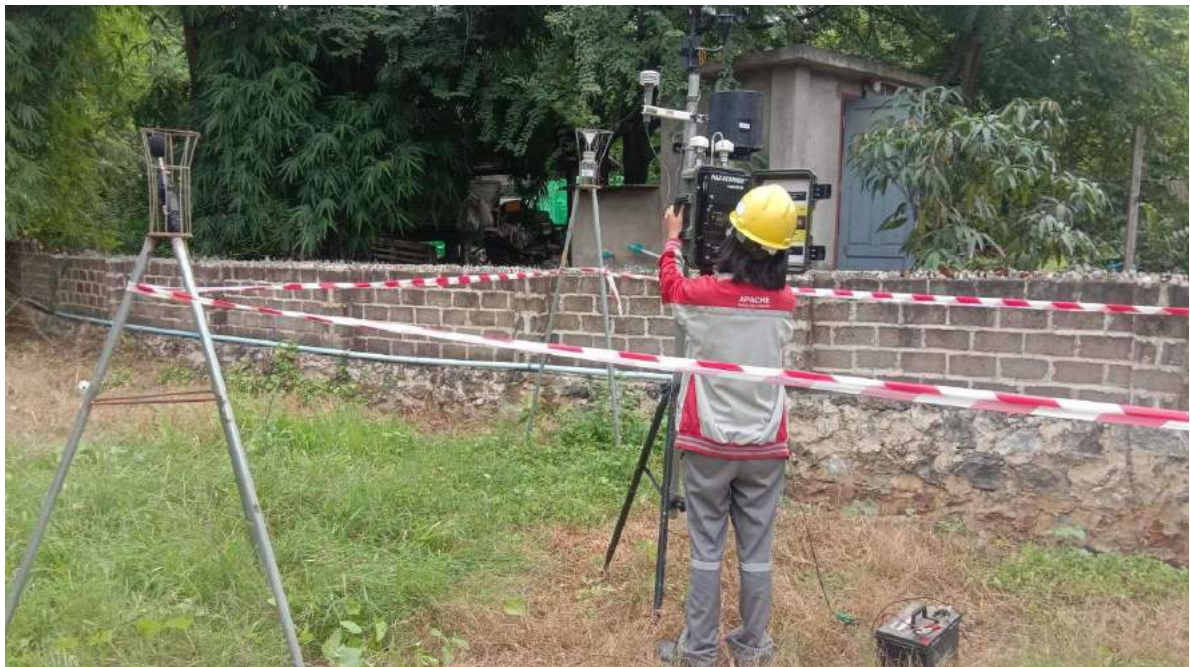
Figure 4. Ambient Air Quality Monitoring

Ambient air quality monitoring location had been selected by identifying potentially affected with consideration given to the prevailing wind conditions through Operation and Construction activities.

No	Monitoring Location	Latitude	Longitude
1	AQ1_Worker Accommodation	20°50'56.15"N	96°23'35.97"E
2	AQ2_Ku Pyin Village	20°53'20.47"N	96°23'27.58"E
3	AQ3_Pyi Nyaung Village	20°49'4.58"N	96°23'40.42"E

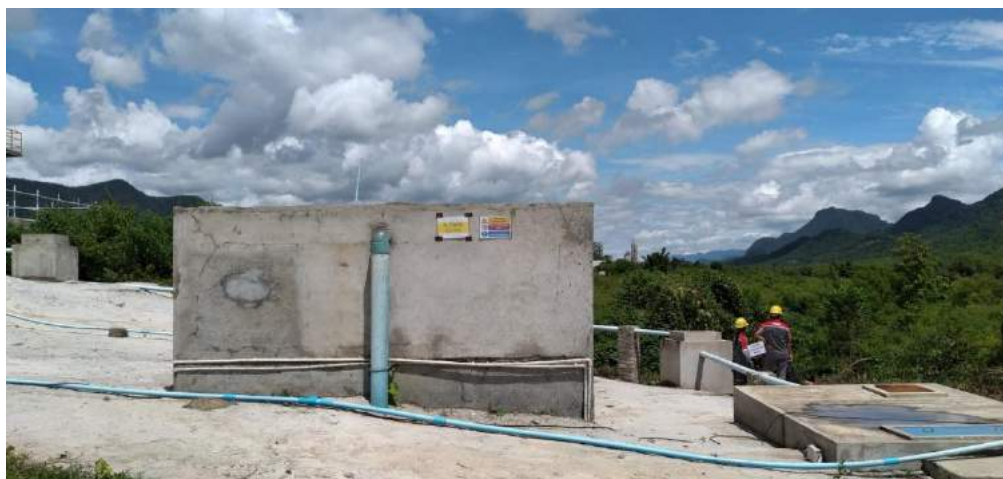
Figure 9 – Bio Tank

No	Sampling Location	Latitude	Longitude
1	Bio Tank Effluent Discharge to Sedimentation # 9	20°50'51.2"N	96°23'45.4"E
2	Supply Water	20°51'35.3"N	96°23'37.7"E
3	Sedimentation Pond Effluent	20°52'14.0"N	96°23'23.6"E

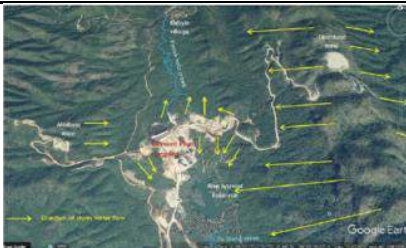
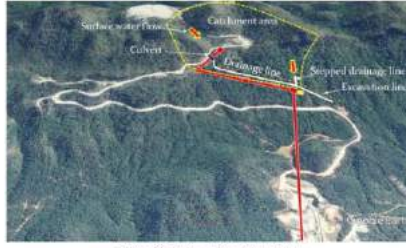
Affected Aspect	Mitigation Measures	Action Taken	Photos
Surface Water Quality	<ul style="list-style-type: none"> Implementing storm water management practices to manage the flow of storm-water, prevent uncontrolled migration and minimize erosion and sediment transport from project facilities and disturbed areas. Construction of a dedicated drainage network to intercept and diversion runoff; 	Constructed stormwater drain around the cement plant channel to sedimentation ponds

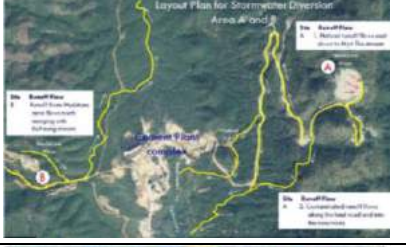
<p style="text-align: center; font-size: small;">Figure (2) Drainage for catchment area</p>
	<ul style="list-style-type: none"> Divert runoff from the mudstone quarry to an appropriately sized and maintained sedimentation pond to allow adequate retention time for suspended solids to settle; 	Constructed sedimentation pond dual stage.	<p style="font-size: x-small;">Sedimentation pond from storm water runoff to allow adequate retention time for suspended solids to settle before entering outfalls area.</p> <p style="text-align: center; font-size: x-small;">Location Map of Sedimentation Pond at STC Site</p>

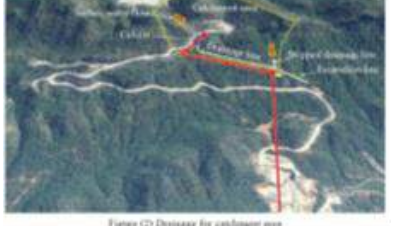
<p style="text-align: center; font-size: small;">Figure (2) Drainage for catchment area</p>
	<ul style="list-style-type: none"> Baffles or other measures to reduce the velocity of runoff downhill slopes should be installed to minimize scouring; 	Visual monitoring by MNE

<ul style="list-style-type: none"> Divert runoff from the limestone quarry to the wetland created by STC via a weir to remove suspended solids before entering the wetland; 	Constructed sedimentation pond dual stage.

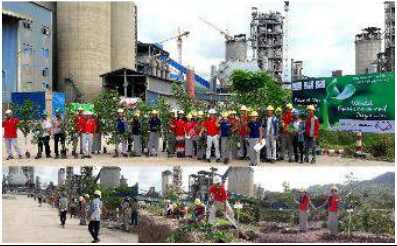
<ul style="list-style-type: none"> Exposed areas and overburden dumps should be revegetated as quickly as possible. 	<p>Tree planting during monsoon season</p>

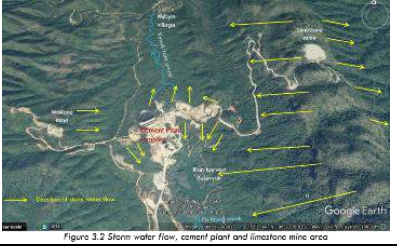
<ul style="list-style-type: none"> STC will prepare and implement a Storm water Management Plan taking into account the mitigation committed above. 	<p>Plan have been developed and construction on progress for Line 2 area. Line 1 area was constructed since 2014.</p>

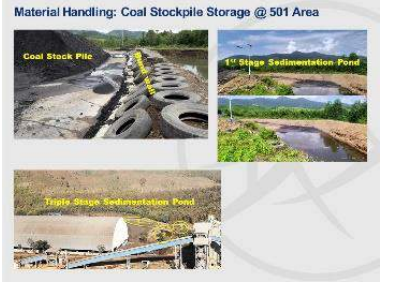
<ul style="list-style-type: none"> All areas used to store and/or handle coal, laterite and limestone should be paved and surrounded by perimeter drains. For the coal storage area, it should be covered; 	<p>Implemented and covered during monsoon season</p>

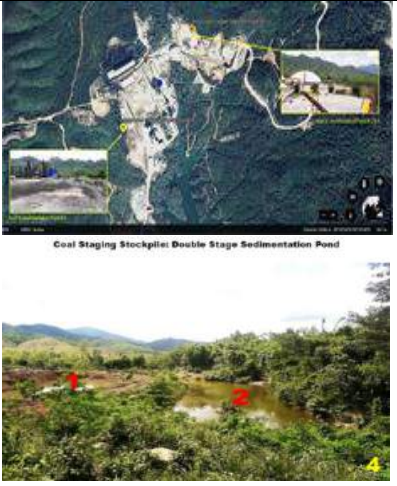
<ul style="list-style-type: none"> Runoff from the laterite and limestone staging areas shall be diverted to retention ponds and may be used for greening, dust suppression or discharged to the onsite reservoir. 	<p>Constructed sedimentation pond dual stage and reuse for gardening and dust control.</p>

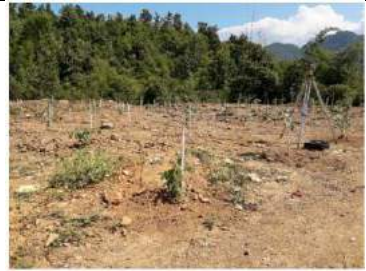
<p>Former landfill was backfilled with top soil and conducted re-plantation.</p>

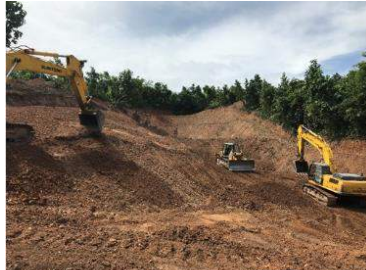
<p>Constructed Temporary Solid Non-hazardous wastes storage equipped with clay liner..</p>

<p>Temporary Solid Non-hazardous wastes storage inspected by ECD and other government entities for the approval of EIA.</p>

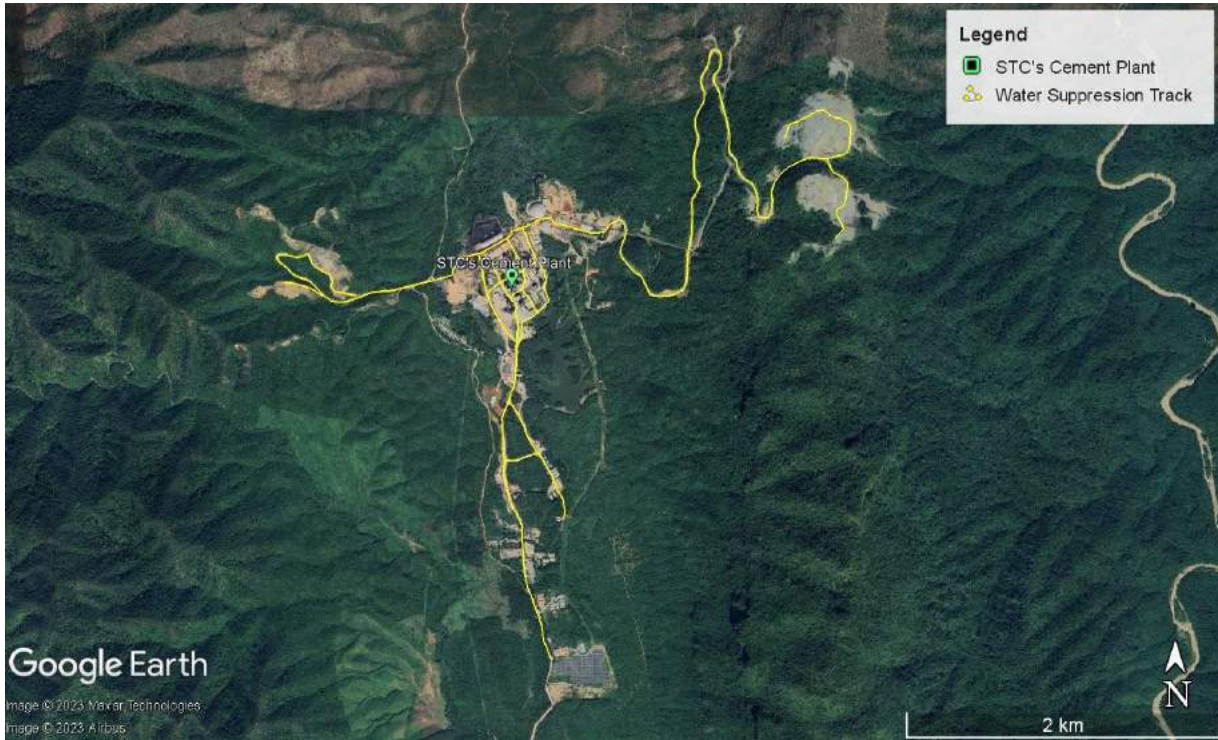
Figure- Water Suppression Map to mitigate dust emission in plant site

The use of fabric filter system and electrostatic precipitator to collect and control fine suspended particulate emissions are implemented. Water suppression are also undertaken on the roads to mitigate dust emission on surrounding area in plant site and accommodation area. (See in Appendix).
