SHWE TAUNG MINING COMPANY LIMITED

Mudstone Quarry

Biannual Environmental Monitoring Report

(December 2022 to May 2023)

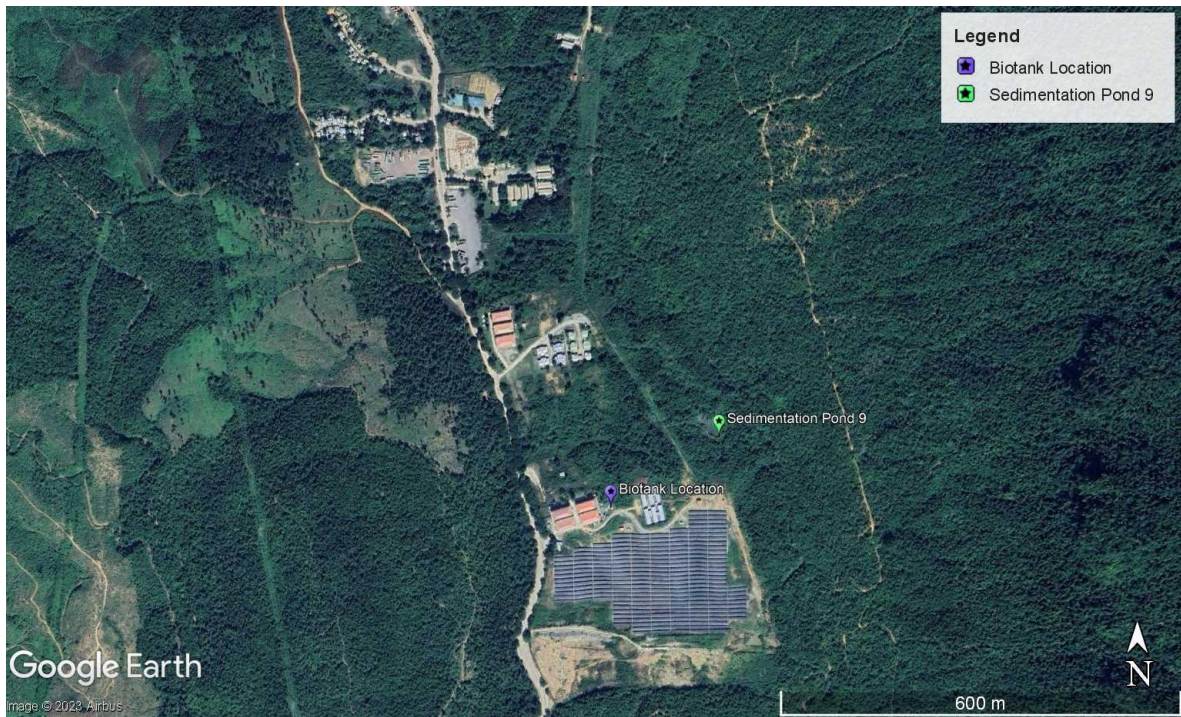
Figure 12 - Overview Map of sampling point for Sanitary Wastewater

Figure 10, 11, 12 and 13 shows the location of Water Quality sampling point monthly on WHO Drinking Water Guidelines and IFC Effluent Water Guidelines for Water Quality Monitoring (e.g. pH, Color, Turbidity, Iron, BOD, COD etc.) are the parameters for measurement.

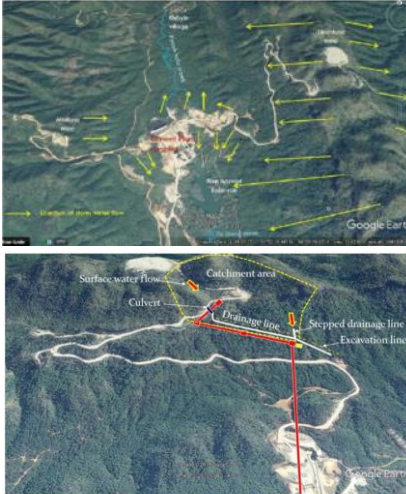
Affected Aspect	Mitigation Measures	Action Taken	Photos
Surface Water Quality	<ul style="list-style-type: none"> Implementing storm water management practices to manage the flow of storm-water, prevent uncontrolled migration and minimize erosion and sediment transport from project facilities and disturbed areas. Construction of a dedicated drainage network to intercept and diversion runoff; 	Constructed stormwater drain around the cement plant channel to sedimentation ponds

<p>Figure (2) Drainage for catchment area</p>
	<ul style="list-style-type: none"> Divert runoff from the mudstone quarry to an appropriately sized and maintained sedimentation pond to allow adequate retention time for suspended solids to settle; 	Constructed sedimentation pond dual stage.	<p>Sedimentation pond from storm water runoff to allow adequate retention time for suspended solids to settle before entering wetlands area.</p> <p>Location Map of Sedimentation Pond at STC Site</p>

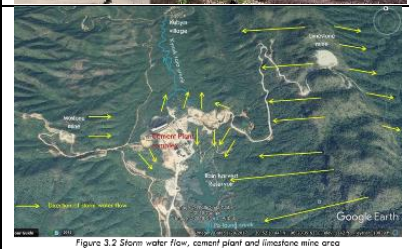
<p>Figure 3.2 Storm water flow, cement plant and limestone mine area</p>
	<ul style="list-style-type: none"> All areas used to store and/or handle coal, laterite and limestone should be paved and surrounded by perimeter drains. For the coal storage area, it should be covered; 	<p>Implemented and covered during monsoon season</p>	<p>Material Handling: Coal Stockpile Storage @ 501 Area</p>

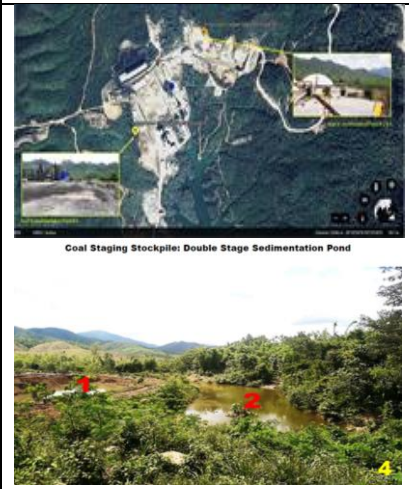
<ul style="list-style-type: none"> Runoff from the laterite and limestone staging areas shall be diverted to retention ponds and may be used for greening, dust suppression or discharged to the onsite reservoir. 	<p>Constructed sedimentation pond dual stage and reuse for gardening and dust control.</p>

<p>Coal Staging Stockpile: Double Stage Sedimentation Pond</p>
