SHWE TAUNG MINING COMPANY LIMITED

Mudstone Quarry
Biannual Environmental Monitoring Report
(June 2023 to November 2023)

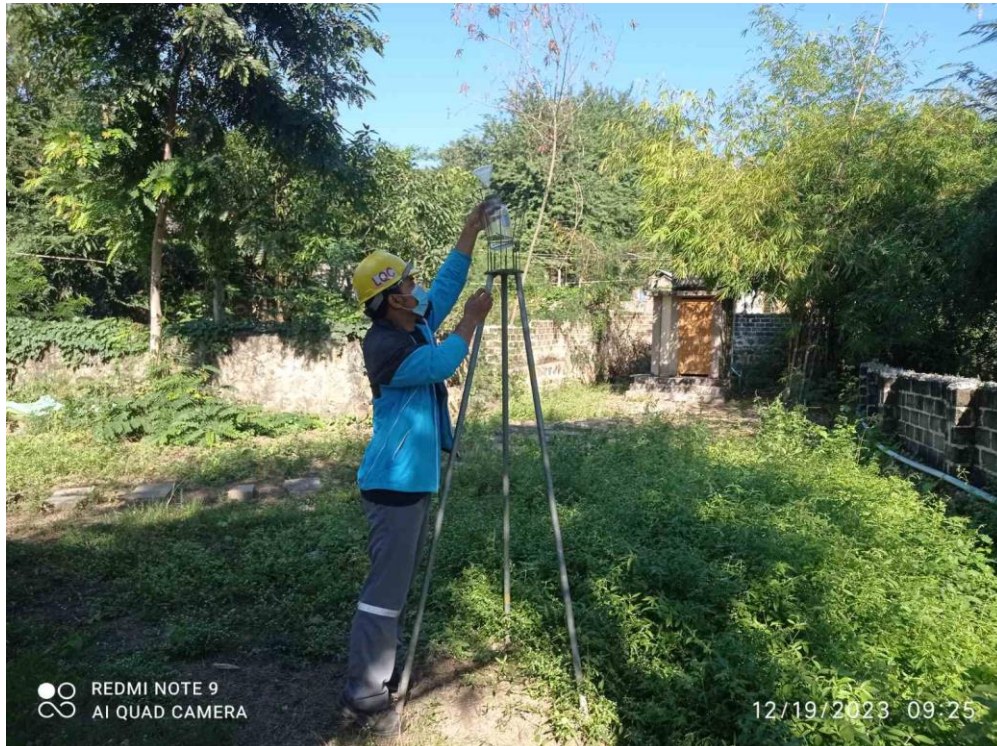
Figure 8 – Dust Deposition Monitoring

No	Monitoring Location	Latitude	Longitude
1	STM Accommodation (Ingyin Hostel)	20°51'23.1"N	96°23'34.7"E
2	STM Accommodation (55acres)	20°50'54.5"N	96°23'34.8"E
3	Ku Pyin (Behind Library)	20°53'26.9"N	96°23'24.8"E
4	Ku Pyin (Primary School)	20°53'25.7"N	96°23'33.6"E
5	Pyi Nyaung (Near Main Road)	20°49'09.5"N	96°23'50.9"E
6	Pyi Nyaung (Information Center)	20°49'03.9"N	96°23'40.6"E

Please refer the table 10 for dust deposition monitoring results from July 2023 to December 2023.

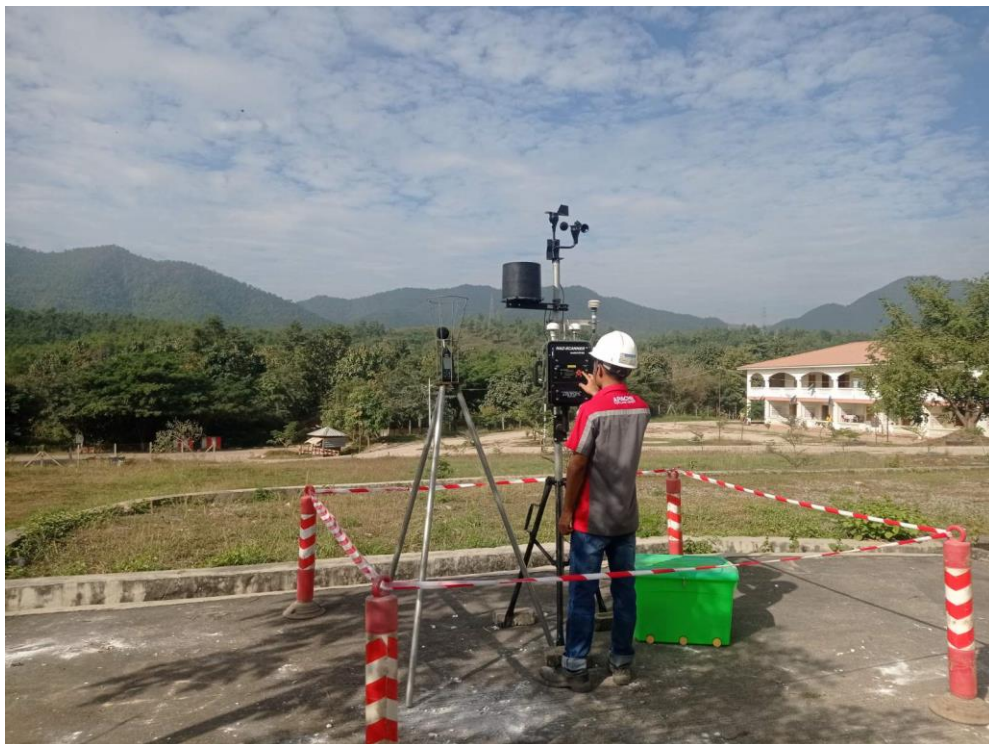
Figure 4. Ambient Air Quality Monitoring

Ambient air quality monitoring location had been selected by identifying potentially affected with consideration given to the prevailing wind conditions through Operation and Construction activities.

No	Monitoring Location	Latitude	Longitude
1	AQ1_Worker Accommodation	20°50'56.15"N	96°23'35.97"E
2	AQ2_Ku Pyin Village	20°53'20.47"N	96°23'27.58"E
3	AQ3_Pyi Nyaung Village	20°49'4.58"N	96°23'40.42"E

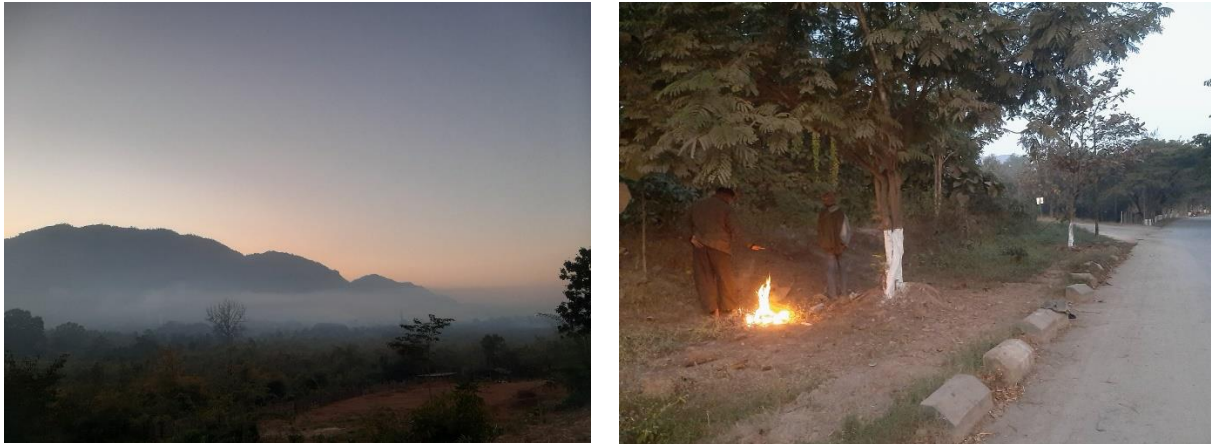
Figure 7 - Human activities affected the Ambient Air Quality around STM Mudstone Quarry

Ambient Air monitoring was monthly tested at location of Sensitive Air Respecters such as Cement Plant Accommodation area and nearby villages which are Pyi Nyaung and Ku Pyin from July 2021 to December 2021, as Cement Plant EIA report (2018). All results are within Myanmar National Environmental Quality (Emission) Guidelines (2015), except higher results of Sulphur Dioxide results. STM has noted that there was a lot of forest bush fires set up by some villagers to clean the bushes, nearly every day.

By analyzing all the AQI results, it is noted that PM_{2.5} values are majorly impacted by human activities (forest firing & open burning, etc.) from surrounding environment. STM will raise the public awareness among Mudstone Quarry community and also disclosed these air quality monitoring results and AQI results at Pyi Nyaung Information Center and Ku Pyin library according to STM Stakeholder Engagement Plan. STM engaged 3rd party Environmental consultant as auditor and the auditor advised that this was the case as forest fires in the hills surrounding the plant were numerous at the time of the audit and consistent haze was present over the general area. The Auditor considered that the forest fires are contributing to elevated particulate readings being recorded by STM and elevated readings cannot be solely apportioned to emissions from Mudstone Quarry and associated facilities.

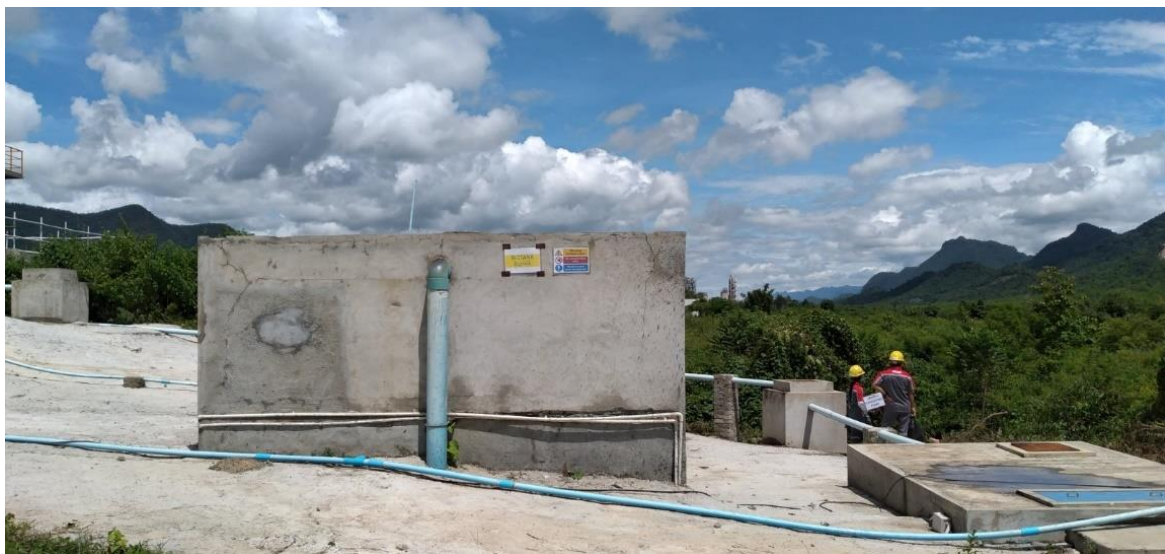
Figure 9 – Bio Tank

No	Sampling Location	Latitude	Longitude
1	Bio Tank Effluent Discharge to Sedimentation # 9	20°50'51.2"N	96°23'45.4"E
2	Supply Water	20°51'35.3"N	96°23'37.7"E
3	Sedimentation Pond Effluent	20°52'14.0"N	96°23'23.6"E

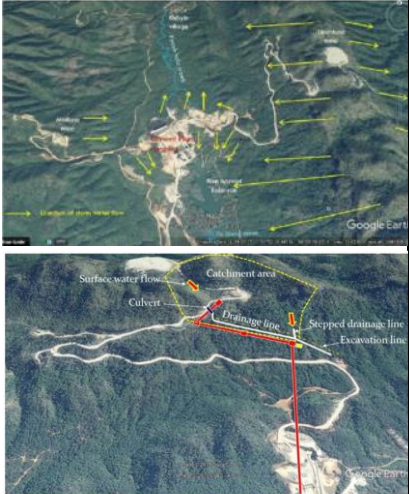
<p>Figure (2) Drainage for catchment area</p>
	<ul style="list-style-type: none"> Divert runoff from the mudstone quarry to an appropriately sized and maintained sedimentation pond to allow adequate retention time for suspended solids to settle; 	Constructed sedimentation pond dual stage.	<p>Sedimentation pond from storm water runoff to allow adequate retention time for suspended solids to settle before entering wetlands area.</p> <p>Location Map of Sedimentation Pond at STC Site</p>

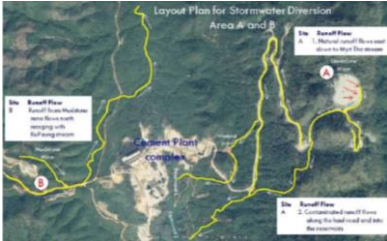
<p>Layout Plan for Stormwater Diversion Area A and B</p>

<ul style="list-style-type: none"> Divert runoff from the limestone quarry to the wetland created by STM via a weir to remove suspended solids before entering the wetland; 	Constructed sedimentation pond dual stage.

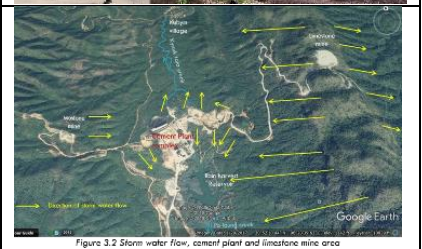
<p>World Environment Day 2020: Plant a Tree</p>
	<ul style="list-style-type: none"> STM will prepare and implement a Storm water Management Plan taking into account the mitigation committed above. 	<p>Plan have been developed and construction on progress for Line 2 area. Line 1 area was constructed since 2014.</p>

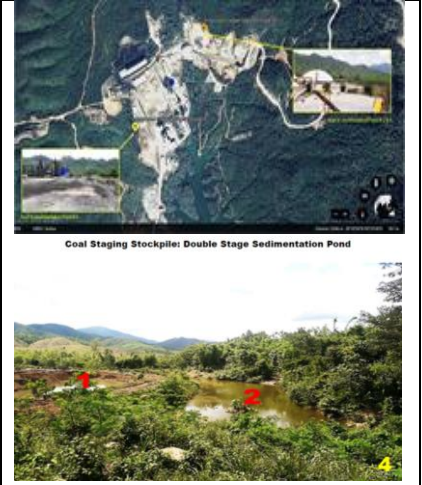
<p>Coal Staging Stockpile: Double Stage Sedimentation Pond</p>
	<ul style="list-style-type: none"> For the coal storage area, STM has agreed to cover this area. Water from the roof will be diverted via storm water drains to retention ponds and may be used for greening, dust suppression or discharged to the onsite reservoir. Runoff collected by the interceptor drains (small volume) within the covered coal storage area will be diverted for treatment at the wastewater treatment plant. 	<p>Constructed sedimentation pond triple stage.</p>

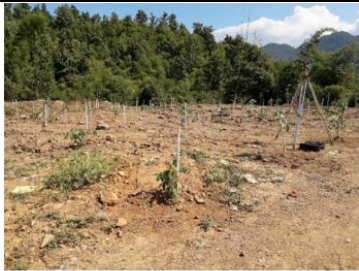
<p>Former landfill was backfilled with top soil and conducted re-plantation.</p>

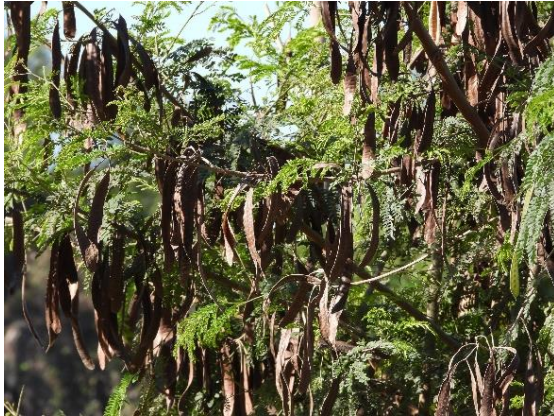
Leucaena leucocephala

Figure18 – Invasive Species Survey

Date	Location	Species Found	Density	Control Measure
24 July 2023	47Q 228457 E 2308612 N	<i>Bidens pilosa</i> , <i>Ageratum conyzoides</i>	High	Mechanical
24 July 2023	47Q 228537 E 2309146 N	<i>Ziziphus jujuba</i> , <i>Chromolaena odorata</i> , <i>Mimosa pudica</i>	Low	No need to be clean
24 July 2023	47Q 228912 E 2310128 N	<i>Mimosa pudica</i> , <i>Chromolaena odorata</i> , <i>Leucaena leucocephala</i> , <i>Oroxylum indicum</i>	Low	No need to be clean
11 December 2023	47Q 228239 E 2309796 N	<i>Mimosa pudica</i> , <i>Leucaena leucocephala</i> , <i>Chromolaena odorata</i> , <i>Oroxylum indicum</i>	Low	No need to be clean
11 December 2023	47Q 228579 E 2308897 N	<i>Mimosa pudica</i> , <i>Bidens pilosa</i>	Medium	Mechanical
11 December 2023	47Q 228377 E 2309312 N	<i>Leucaena Leucocephala</i> , <i>Chromolaena odorata</i> , <i>Ziziphus jujuba</i> , <i>Mimosa pudica</i> , <i>Ageratum conyzoides</i>	High	Mechanical

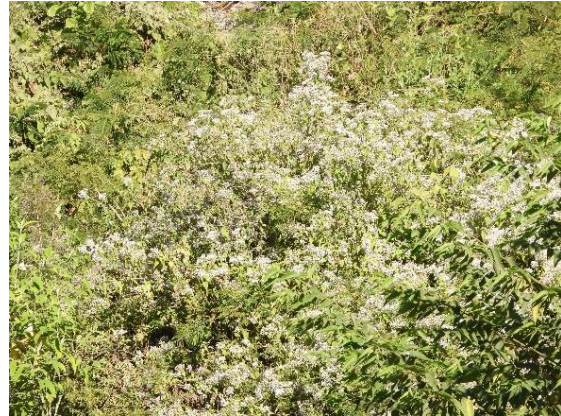
Chromolaena odorata
