SHWE TAUNG MINING COMPANY LIMITED

Bi-Annual Environmental Monitoring Report

Mudstone Quarry Biannual Environmental Monitoring Report (November 2023 to April 2024)

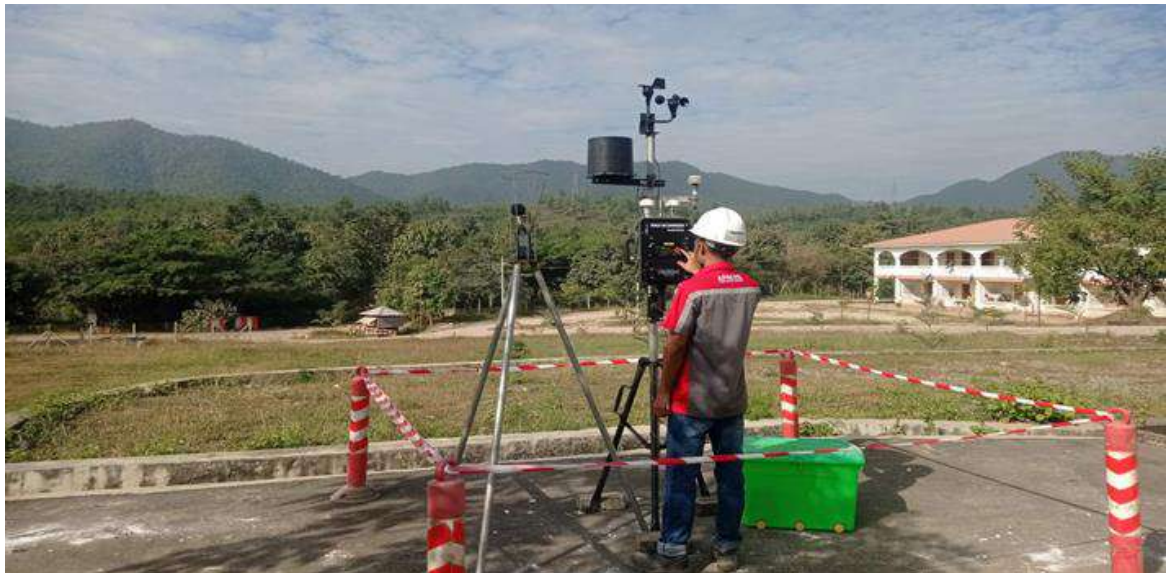
Figure-4: Ambient Air Quality Monitoring

Ambient air quality monitoring location had been selected by identifying potentially affected with consideration given to the prevailing wind conditions through Operation and Construction activities.

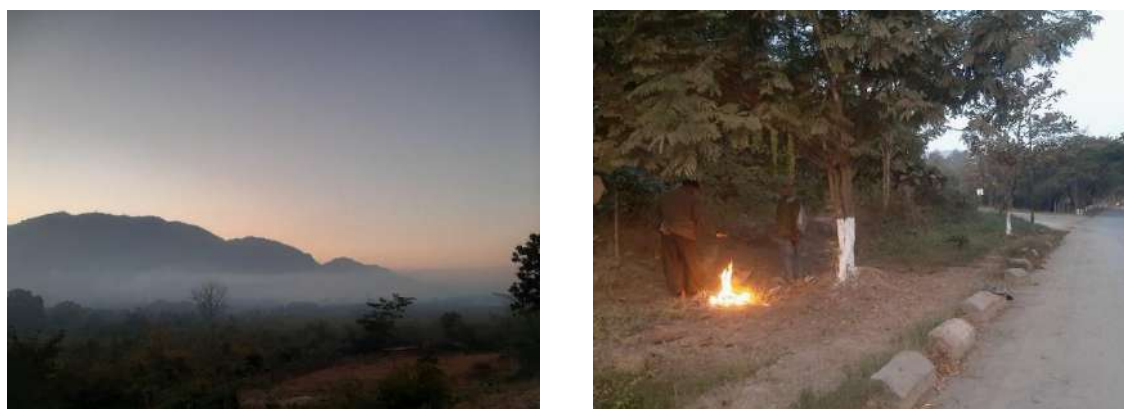
Figure-7: Human activities affected the Ambient Air Quality around STM Mudstone Quarry

Ambient Air monitoring was monthly tested at location of Sensitive Air Respectsers such as Cement Plant Accommodation area and nearby villages which are Pyi Nyaung and Ku Pyin from July 2021 to December 2021, as Cement Plant EIA report (2018). All results are within Myanmar National Environmental Quality (Emission) Guidelines (2015), except higher results of Sulphur Dioxide results. STM has noted that there was a lot of forest bush fires set up by some villagers to clean the bushes, nearly every day.

By analyzing all the AQI results, it is noted that PM 2.5 values are majorly impacted by human activities (forest firing & open burning, etc.) from surrounding environment. STM will raise the public awareness among Mudstone Quarry community and also disclosed these air quality monitoring results and AQI results at Pyi Nyaung Information Center and Ku Pyin library according to STM Stakeholder Engagement Plan.

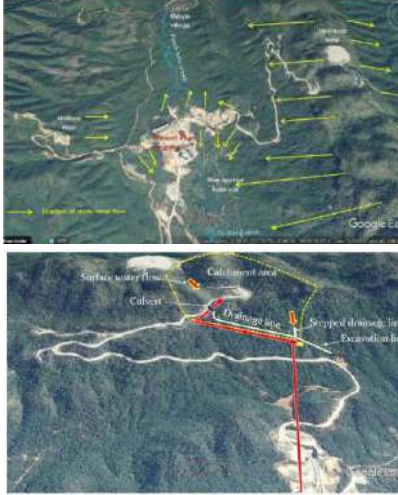
Affected Aspect	Mitigation Measures	Action Taken	Photos
Surface Water Quality	<ul style="list-style-type: none"> Implementing storm water management practices to manage the flow of storm-water, prevent uncontrolled migration and minimize erosion and sediment transport from project facilities and disturbed areas. Construction of a dedicated drainage network to intercept and diversion runoff; 	Constructed stormwater drains around the cement plant channel to sedimentation ponds

<p>Figure (2) Drainage for catchment area</p>
	<ul style="list-style-type: none"> Divert runoff from the mudstone quarry to an appropriately sized and maintained sedimentation pond to allow adequate retention time for suspended solids to settle; 	Constructed sedimentation pond dual stage.	<p>Sedimentation pond from storm water runoff to allow adequate retention time for suspended solids to settle before entering wetlands area.</p>

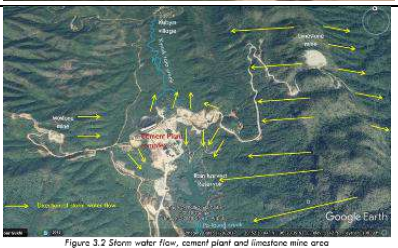
<ul style="list-style-type: none"> STM will prepare and implement a Storm water Management Plan considering the mitigation committed above. 	<p>Plan have been developed and construction on progress for Line 2 area. Line 1 area was constructed since 2014.</p>

<p>Figure 3.2 Storm water flow, cement plant and limestone mine area</p>
	<ul style="list-style-type: none"> All areas used to store and/or handle coal, laterite and limestone should be paved and surrounded by perimeter drains. For the coal storage area, it should be covered; 	<p>Implemented and covered during monsoon season</p>	<p>Material Handling: Coal Stockpile Storage @ 501 Area</p>

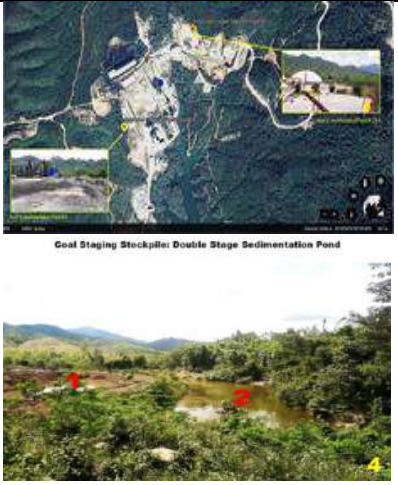
<ul style="list-style-type: none"> Runoff from the laterite and limestone staging areas shall be diverted to retention ponds and may be used for greening, dust suppression or discharged to the onsite reservoir. 	<p>Constructed sedimentation pond dual stage and reuse for gardening and dust control.</p>

<p>Coal Staging Stockpile: Double Stage Sedimentation Pond</p>
	<ul style="list-style-type: none"> For the coal storage area, STM has agreed to cover this area. Water from the roof will be diverted via storm water drains to retention ponds and may be used for greening, dust suppression or discharged to the onsite reservoir. Runoff collected by the interceptor drains (small volume) within the covered coal storage area will be diverted for treatment at the wastewater treatment plant. 	<p>Constructed sedimentation pond triple stage.</p>

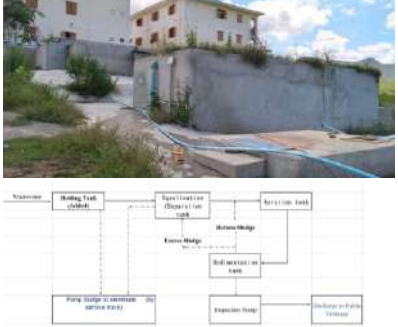
<ul style="list-style-type: none"> Sanitary wastewater (includes toilet, sink, shower) should be discharged to the wastewater treatment plant and not be directly discharged to any water bodies. Kitchen flows should be discharged for treatment at dedicated grease trap / water purification unit and not be directly discharged to any water bodies. 	<p>Constructed Bio Tank for treatment of sanitary wastewater.</p>

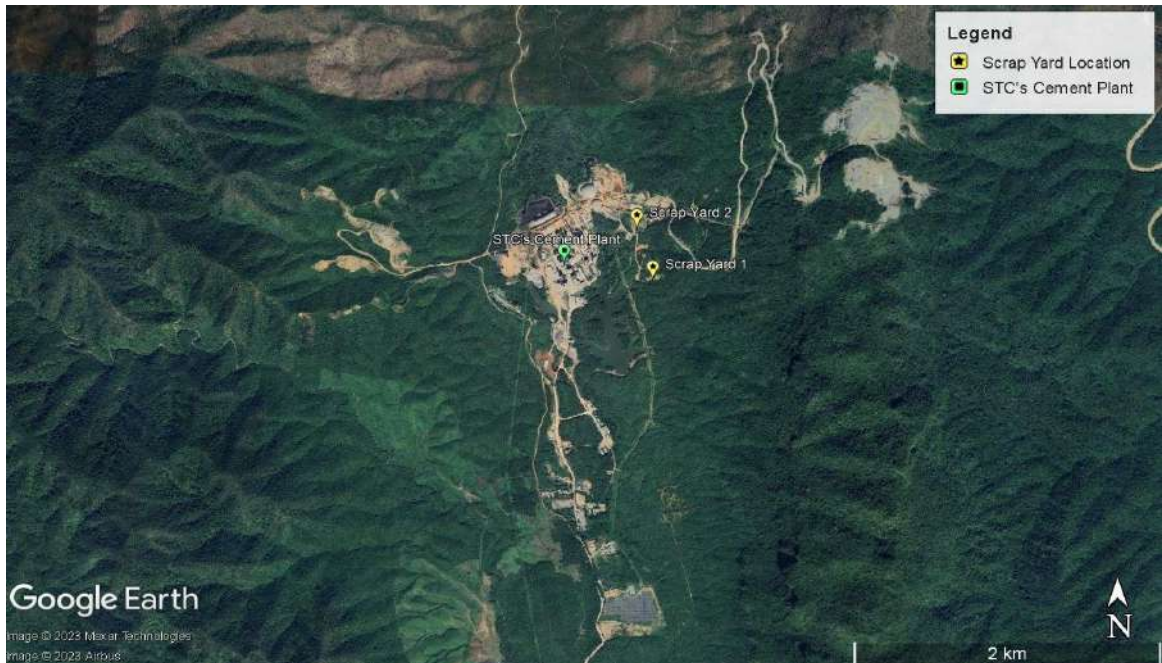
Figure-16: Location Map of Site Waste Dumping Area (Scrap Yard)

<ul style="list-style-type: none"> Segregate wastes and recycle wherever possible; 	<p>Segregated scrap materials for resale and reuse (See Figure-13 for Scrap Yard Area)</p>

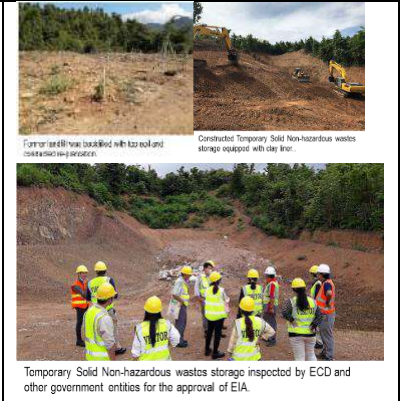
<ul style="list-style-type: none"> The existing landfill is not lined and should be only used for inert (non-reactive) and non-hazardous waste only. 	<p>Implemented (Constructed Old Temporary Non-hazardous solid storage area for disposing Non-hazardous waste and operated it from 2012 to June 2019. Replantation in old place after closure. After inspection of New Temporary Non-hazardous solid storage area from ECD and governmental organizations in 5 July 2019, operate that one until now.)</p>

<p>Former landfill now landscaped with top soil and replanted with vegetation.</p> <p>Constructed Temporary Solid Non-hazardous wastes storage equipped with clay liner.</p> <p>Temporary Solid Non-hazardous wastes storage inspected by ECD and other government entities for the approval of EIA.</p>

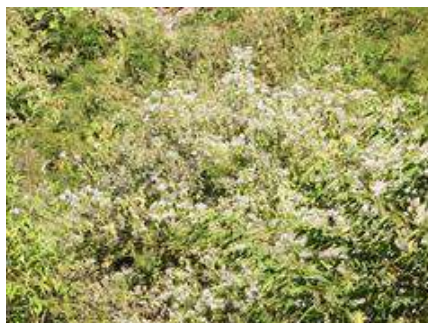
Figure-17: Invasive Species Survey

These dominant species mostly found cement plant and should control in time. *Mimosa pudica* (Htikayone) should collect and burned to control distribution. *Leucaena leucocephala*, (Bawsakaing) should cut the tree before fruiting season and dig the root to stop coppicing. *Chromolaena odorata* (Bizat) should cut the bushes and burn before flowering season. They can reproduce especially in wind dispersal methods and sometime by animals and trucks. Detail survey will make in quarterly to monitor the distribution of invasive species. We should also use herbicide to control some invasive species.

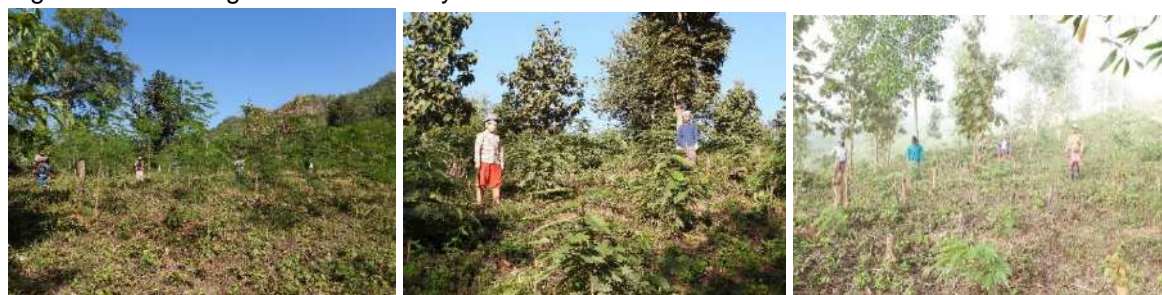
Figure-18: Patching Process at Ecosystem Restoration Plantation

STM took zero burning practice in all plantation to protect carbon emission from our activities. It may lead to develop slow growth of some species such as Kyun and Myanmar Kokko. The grow rate of Sein Pan is the best growth rate that average is about 7 ft in South Pyi Nyaung plantation. Mazili grow rate is the best in plantation 65 acre near cement plant. Padauk was damage due to domestic buffalo from near village. STM will mitigate to get better growth rate plantation in next year by changing of planting pattern, selection of species, preparation of soil before planting.

STM has operated fire protection for all patched area in plantation to protect wild fire and its damages.

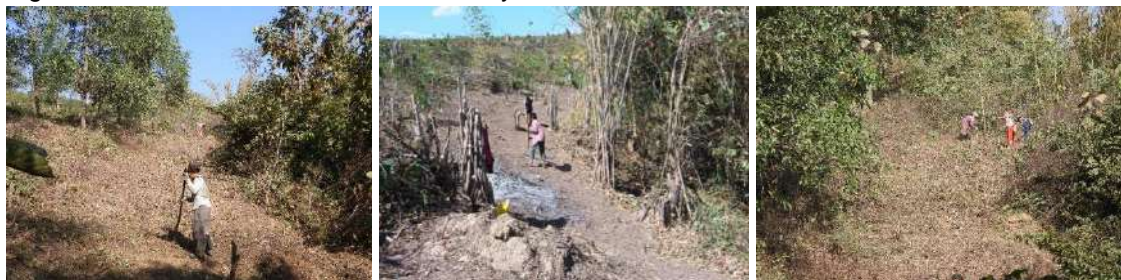
Figure-19: Fire Protection Process at Ecosystem Restoration Plantation

STM has operated fire protection road at ecological system restoration plantation to protect forest fire in summer season. STM use local contractors to give job opportunity from our activities. Fire protection has been finished at the third week of February 2024.

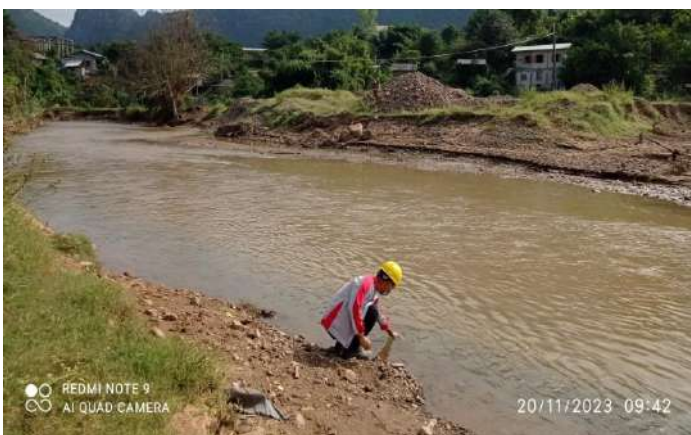
ပုံ - ကူပြင်နှင့်ပြည်ညောင်ကျေးရွာရှိ ချောင်းရေများအား နမူနာကောက်ယူ စစ်ဆေးနေစဉ်။

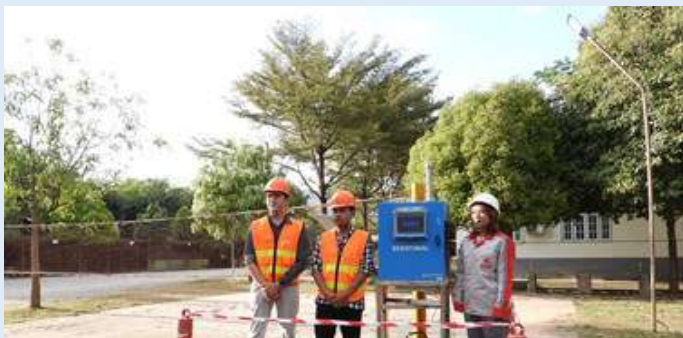
ရွှေတောင်ဘီလပ်မြေကုမ္ပဏီလီမိတက်(အပါချီဘီလပ်မြေ စက်ရုံ)သို့ မိတ္ထီလာခရိုင်၊ပတ်ဝန်းကျင်ထိန်းသိမ်းရေးဌာနမှ လေထုအရည်အသွေးလာရောက်တိုင်းတာ၍စစ်ဆေးခြင်း များအား ပုံမှန် (လစဉ်) အနေဖြင့် ဆောင်ရွက်လျက်ရှိပါသည်။

ပုံ - မိတ္ထီလာခရိုင် ပတ်ဝန်းကျင်ထိန်းသိမ်းရေးဦးစီးဌာနမှ ရွှေတောင် ဘီလပ်မြေကုမ္ပဏီလီမိတက် (အပါချီဘီလပ်မြေ စက်ရုံ) သို့ လေထုအရည်အသွေးလာရောက်တိုင်းတာနေစဉ်။
